## 2024 TECHNICAL AWARDS ENTRY FORM

1. **Brief title of entry:** Vyrnwy Aqueduct Modernisation Programme – Air Pig Technology.....
2. **Company name:** United Utilities & Avove Utilities.....
3. **Signed:** Max Harwood / Jonathan Craggs .....

Air Pigging is an innovative approach for cleaning large diameter pipelines and is an alternative to conventional pressure jet cleaning. It was proposed on this project by facilitating a collaborative approach between United Utilities and Avove and provided substantial benefits including reduced carbon production, water use savings and programme reduction.

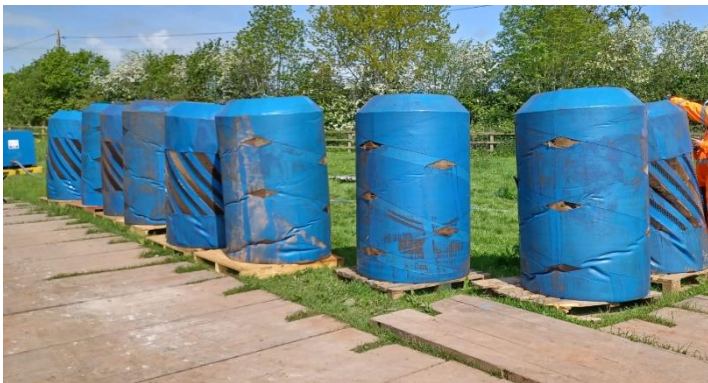
Figure 1 - Various PIG swabs can be used on air pigging.

Air pigging is a technique that has been used in many industries including water but has had limited previous use on the size and scale of the Vyrnwy Aqueducts (1066mm diameter and 17.5km length). The technique involves inserting two foam pigs into the main, 2% larger than the aqueduct diameter, separated by the insertion of a volume of water. See Figures 1,2 and 3 for cleaning swabs. This 'train' is then transported through the aqueduct via pressurised air, compressed and inserted into the main through air valves in launcher and receiver manifolds. The initial foam swab disturbs and dislodges the existing manganese film on the internal wall of the main, with the volume of water between the two swabs picking up these deposits and effectively cleaning the pipeline as it is transported from launch to reception points. Once received, the pressure is reduced through opening a vent valve on the receiver manifold and the initial pig is removed, with the slug of wastewater being pumped out and taken to waste. See Figure 7 for typical details of the launch and reception points temporarily installed onto the aqueduct. The detail included fabricated long radius duck foot bend with a taper and 2 no.1200x2000mm fabricated pig launch pipework. Nominal average pressure to start moving the pig train was recorded at 2 bar, with pressures slightly increased to overcome some obstacles within the pipeline such as settled water at sluice points. Health and safety processes were always followed with thorough risk assessments and method statements created for the works. Additional benefits of this solution include the flexibility to be able to change the type of pig inserted into the main. For example, the pigging process was also used to CCTV the main after the cleaning of the aqueduct had taken place. This involved a specialist foam swab that included a HD camera within the nozzle, see Figure 4. Tracking technology was also included in the foam swabs meaning the live location could be monitored to ensure operational teams were ready to receive the swabs.

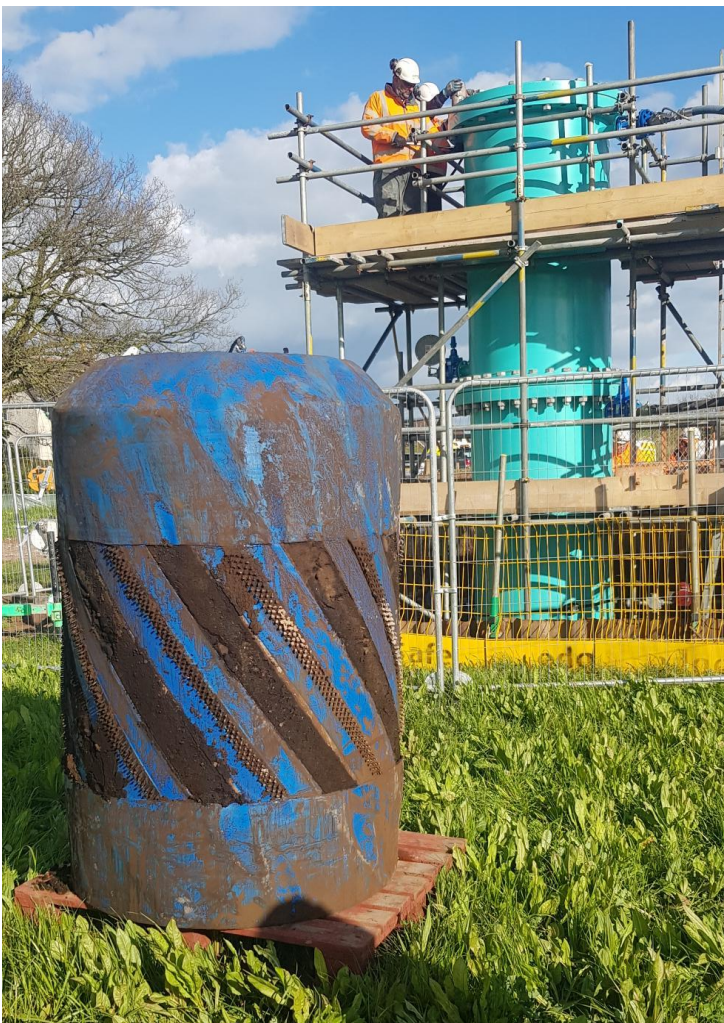
Figure 2 - Cleaning PIG condition after the first run & launcher manifold.

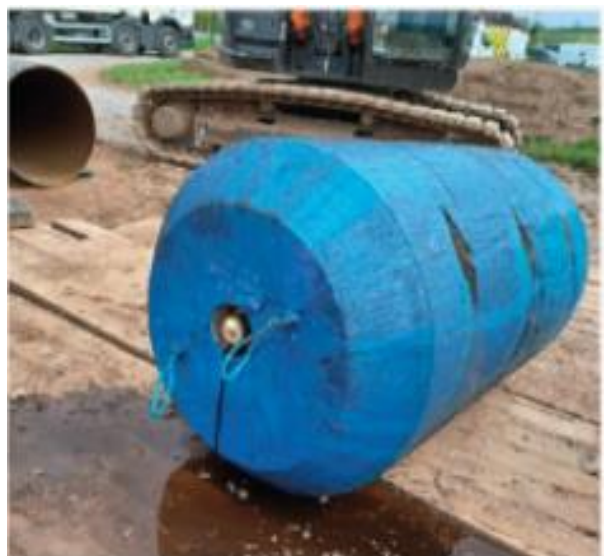
Figure 4 - A camera PIG was used to CCTV the main post cleaning.

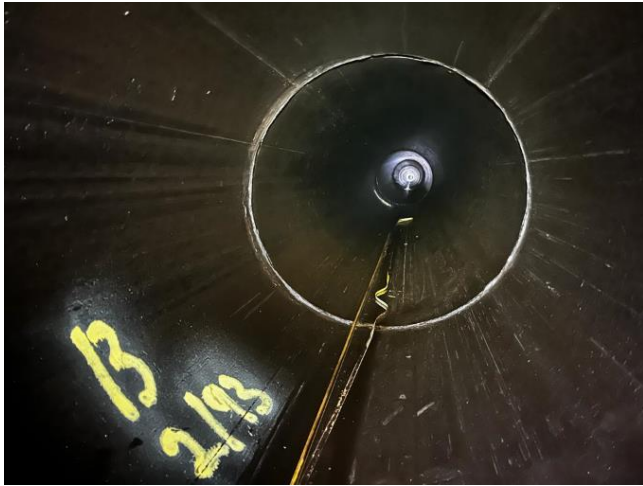
Figure 5 - Post cleaning condition after 4 runs of Air Pigging

So how did it perform? See Figures 5 and 6 for images taken before and after the cleaning had taken place. The air pigging was deemed as a success by both contractor and client alike. Post cleaning inspections presented a very clean pipe, with much of the manganese film removed over the full 3km sections. The internal lining condition after pigging was one of the main concerns with using this technology. The bitumen, although worn in sections due to age, was found to have been hardly impacted by the foam swabs. Invert flushing in the aqueduct removed any excess debris which was limited in volume and mostly present towards the ends of runs once the pigs had become saturated. The duration of invert flushing was 1 day per section for air pigging compared to conventional pressure jetting which usually last at least a week. Operational colleagues noted how quickly pipeline sections were being commissioned due to speed at which the sampling passed based on the cleanliness of the pipe.

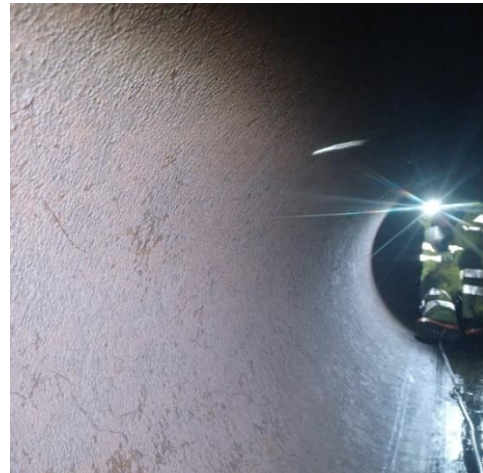
Figure 6 - Pre cleaning of the aqueducts with significant manganese build up.
